TECHNICAL REPORT GL-79-31

# UTILIZATION OF MARGINAL CONSTRUCTION MATERIALS FOR LOC

Geotechnical Laboratory

Final Report

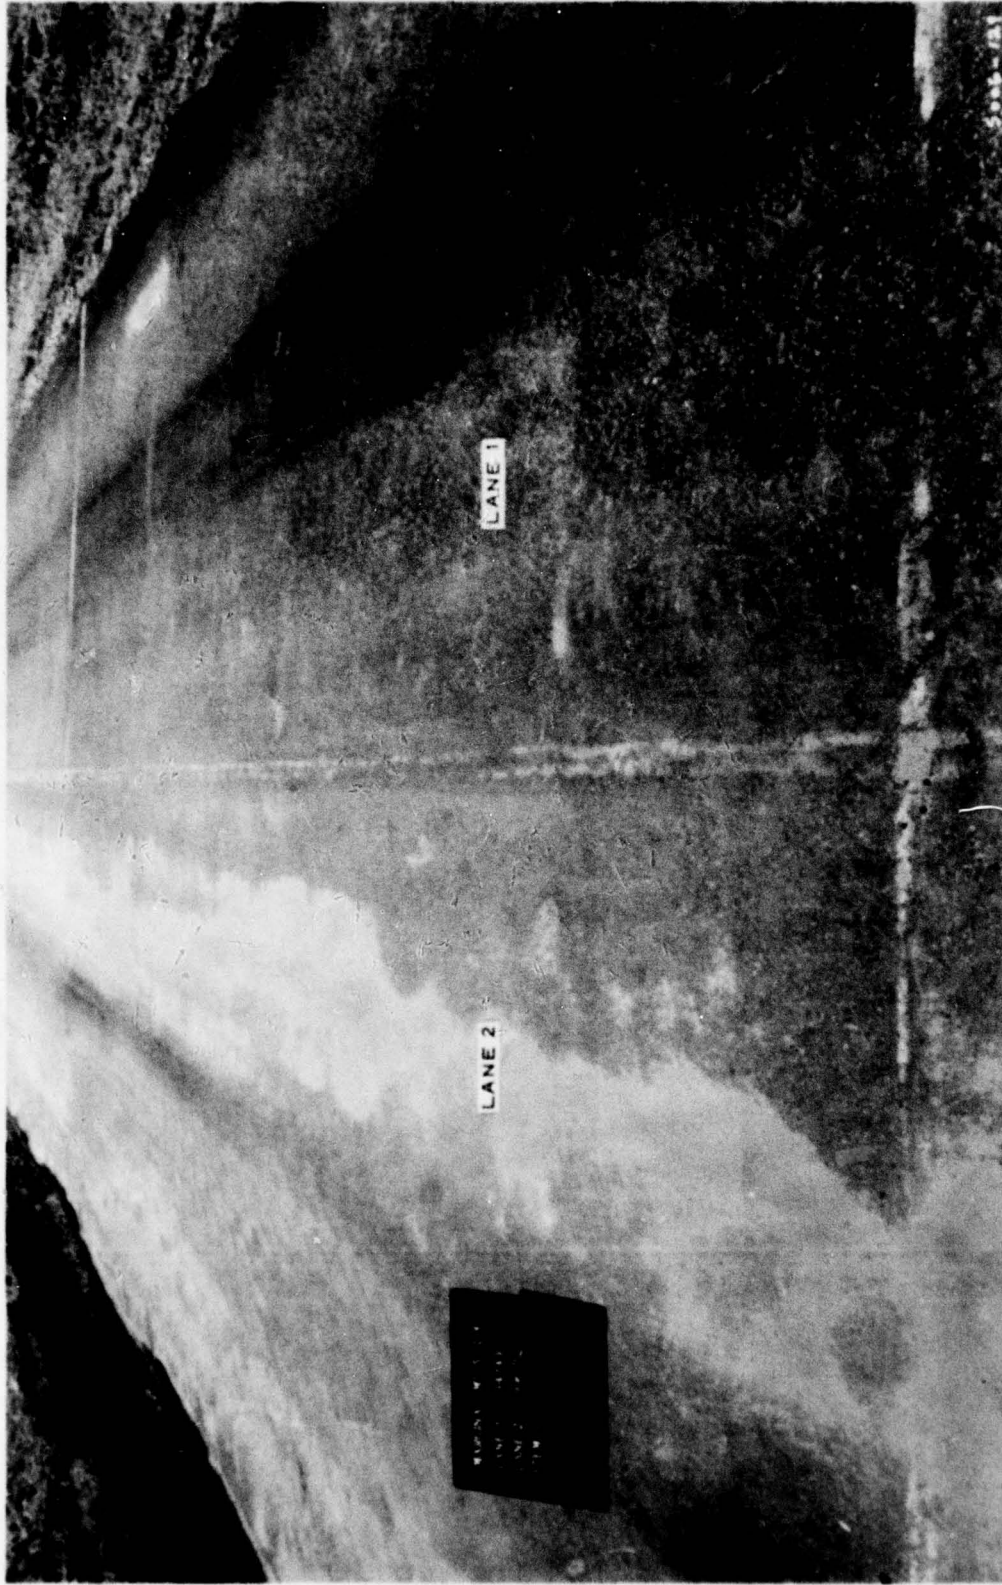
Photo 46. General view of item 10 after traffic (lane 1, 34,143 operations;  
lane 2, 106,752 operations)

a 1/2-in.-deep rut was measured in the outside wheel path; after 8,162 operations, this rut had increased in depth to about 1 in. (Photo 45). Surface rippling of the bituminous mix at the outside edge of the pavement indicating shoving can also be detected in Photo 45. Due to cooler pavement temperatures (70° F or below), very little change in the condition of the pavement occurred as traffic was continued, except for the exposure of the smooth and polished aggregate. After 34,143 operations, traffic was stopped, and this item was considered to be in satisfactory condition. Measurements across the width of the traffic lane at the end of traffic showed rut depths of 1/4 and 1 in. in the inside and outside wheel paths, respectively. An overall view of item 10 after 34,143 operations is shown in Photo 46.

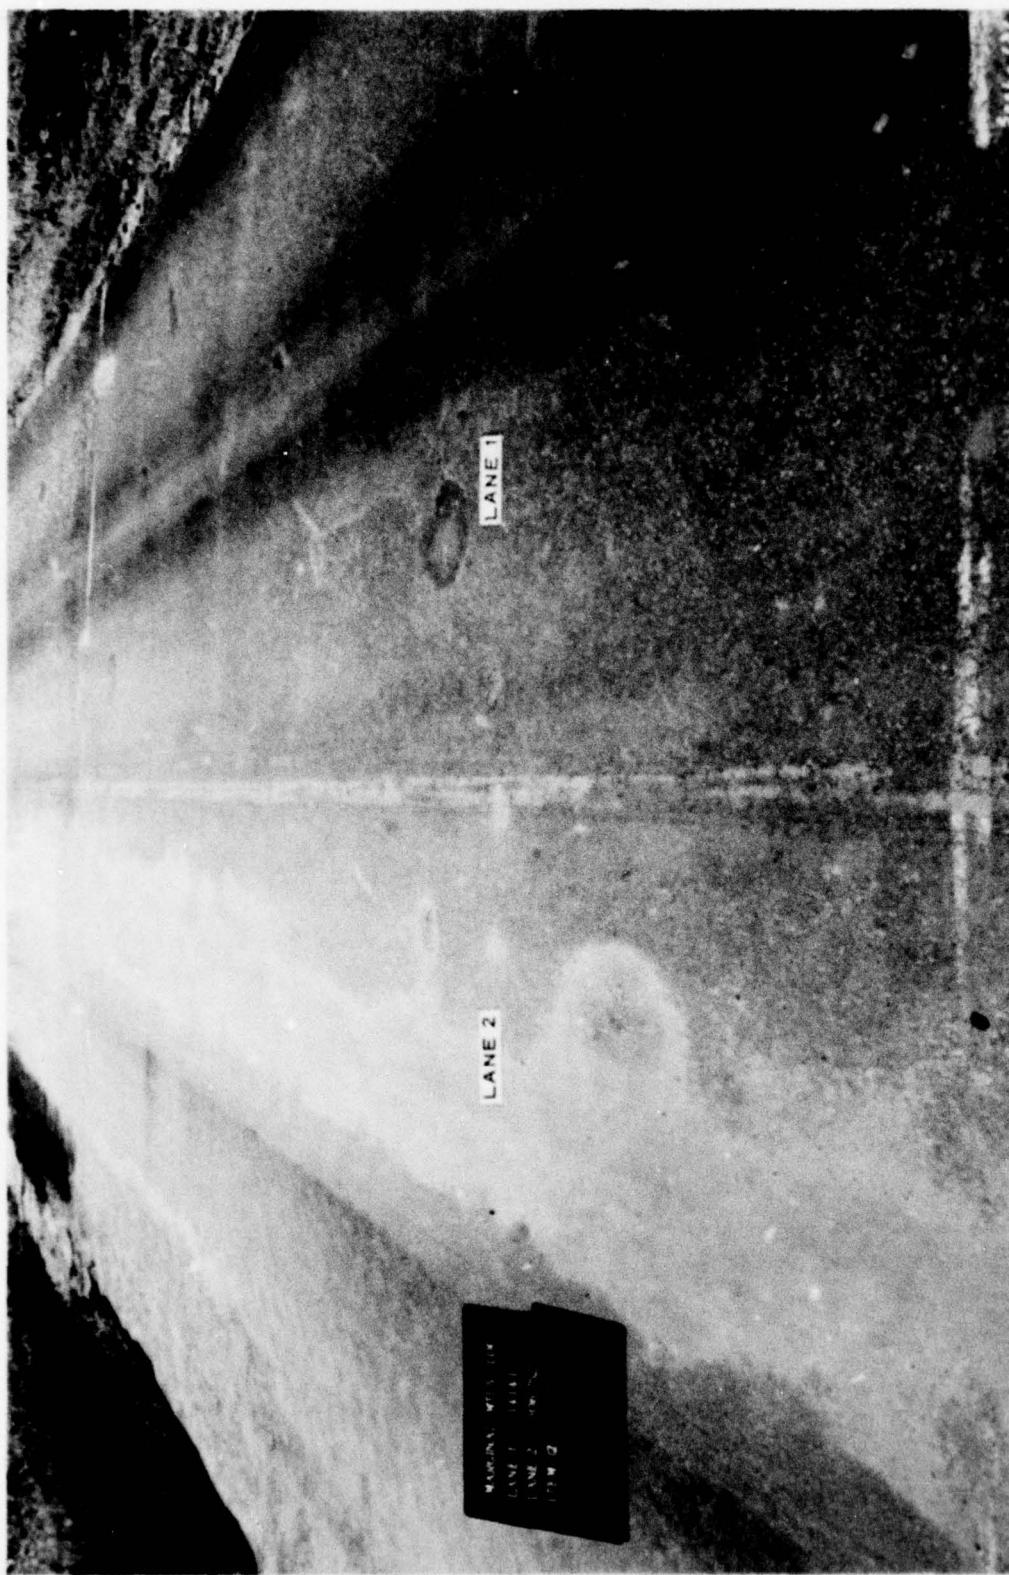
Photo 50. General view of item 12 after traffic (lane 1, 34,143 operations;  
lane 2, 106,752 operations)

66. Items 11 and 12 performed very well during the entire traffic period. General views of these items before traffic are shown in Photos 47 and 48. Slight shoving was detected in both items at the beginning of traffic but seemed to stop after about 8,162 operations. After 8,162 operations, a shallow rut had formed in both test items. The maximum rut depth measured at this time was 1/4 in. in item 11 and 3/8 in. in item 12. Traffic was continued to 34,143 operations, with little or no change in the condition of the two pavements. Indications were that a large number of operations would be required to produce any appreciable distress; therefore, traffic was discontinued. Items 11 and 12 were rated in satisfactory condition at the end of traffic. Photos 49 and 50 show a general view after traffic of items 11 and 12, respectively.

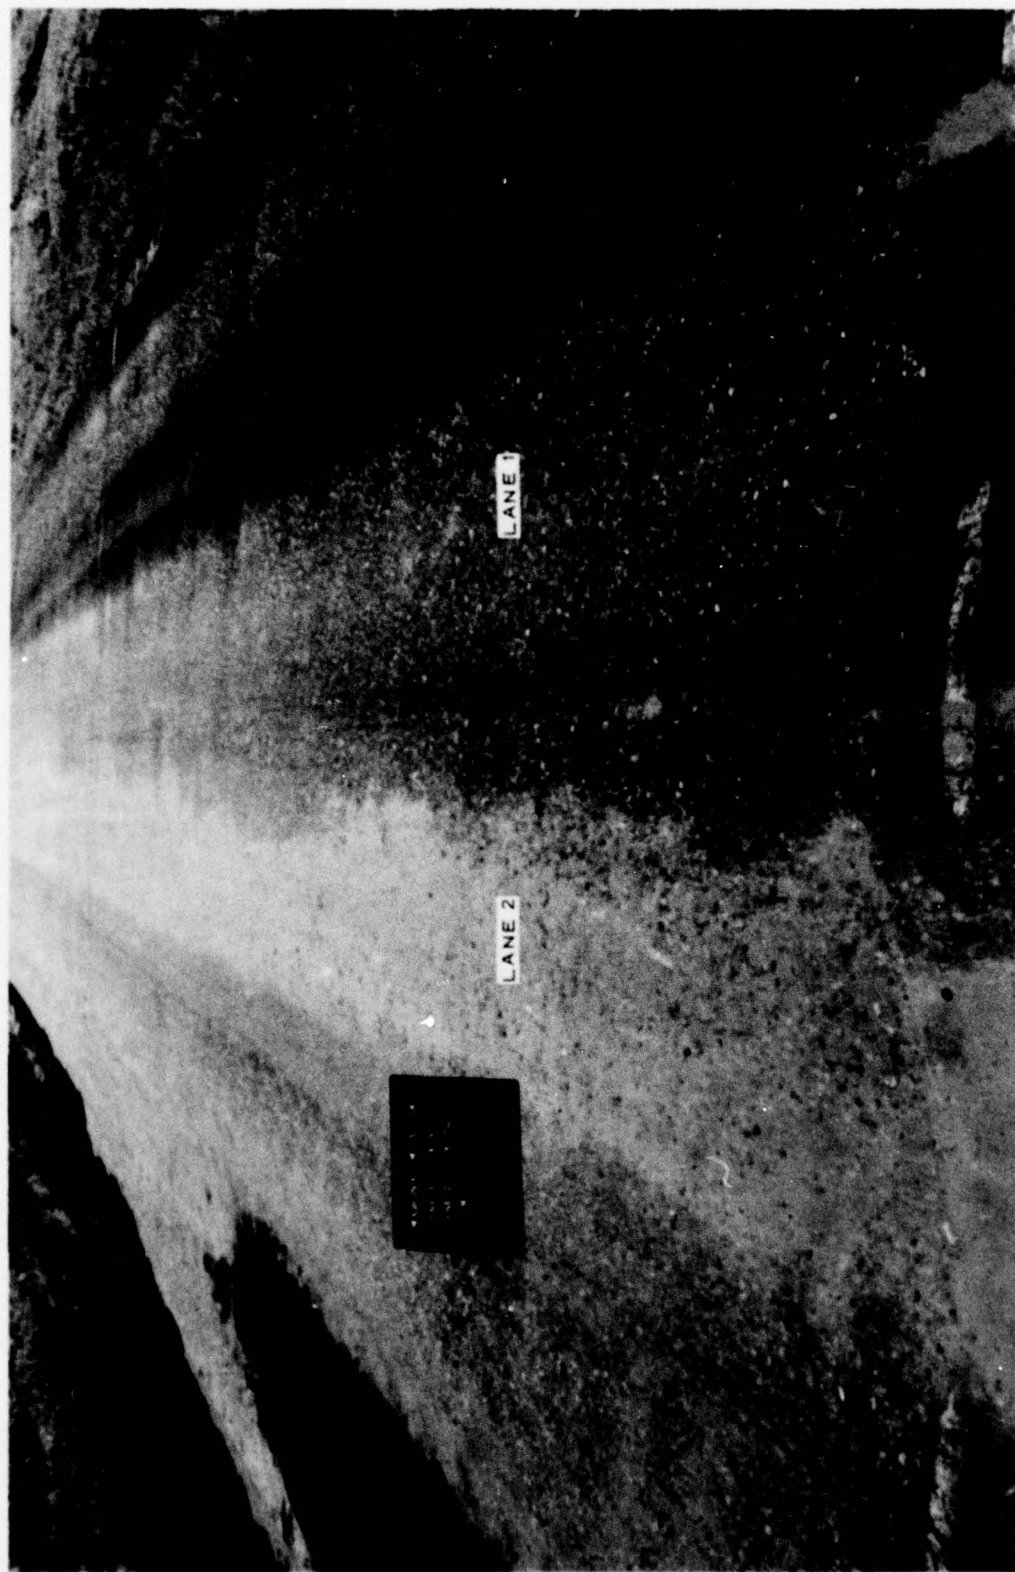
Photo 53. General view of item 13 after traffic (lane 1, 34,143 operations;  
lane 2, 106,752 operations)

in Photo 51. As traffic was applied, slight raveling of the fines and exposure of the smooth surface of the larger aggregate were the only signs of distress observed in item 13. A close-up view depicting surface raveling after 1,450 operations is shown in Photo 52. After approximately 14,323 operations, ruts of about 1/8-in. depth due to raveling were measured in both wheel paths. By 34,143 operations (7,692 during wet weather), these ruts had increased in depth to about 1/4 in. Indications were that wet weather traffic had very little effect on the degree of raveling in this item and that a large number of operations would be required to produce a significant amount of distress in the pavement; therefore, traffic was discontinued at this time. Item 13 was rated in satisfactory condition at the end of traffic. An overall view of this item after 34,143 operations is shown in Photo 53.

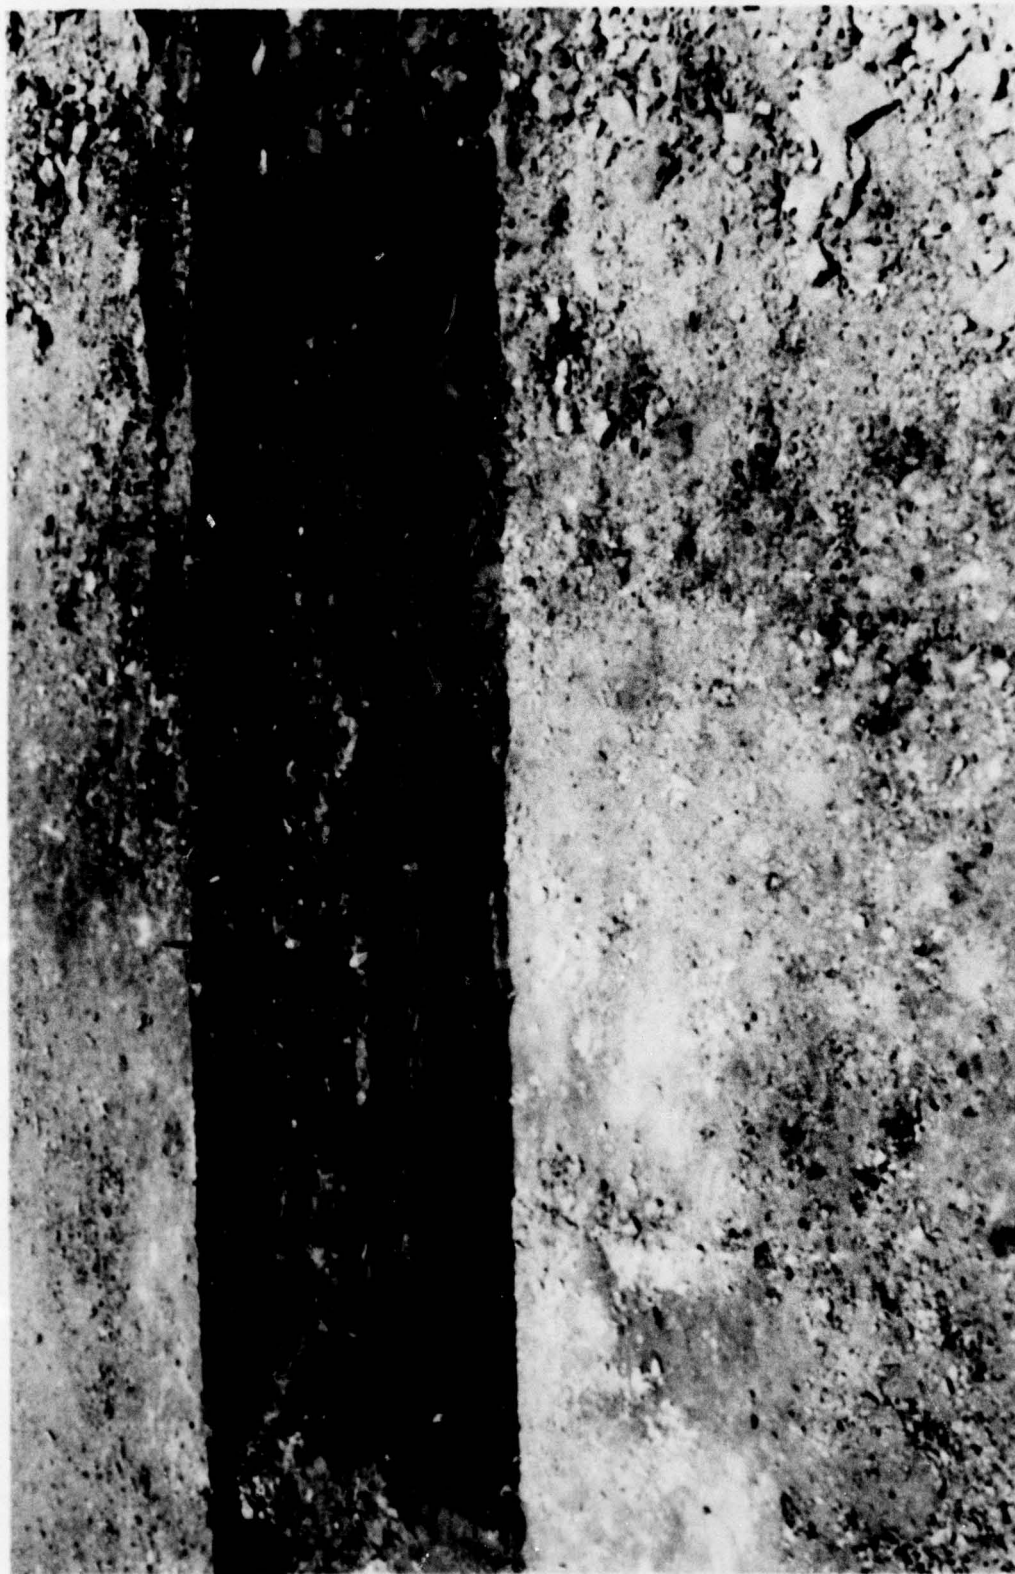
Photo 54. Test trench across item 5, lane 1

69. Failure investigations. After failure in items 6 and 7 and after traffic in item 5, a test trench was excavated across the traffic lane to determine the extent of distortion of the various pavement elements. Views of these test pits are shown in Photos 54-56. In-place CBR, water content, and density determinations were also made of the different elements as these trenches were excavated. Results of these tests are presented in Table 11. A summary of thickness measurements of the bituminous pavement layers and the total thickness over the subgrade as measured in the test trenches is also shown in Table 11.

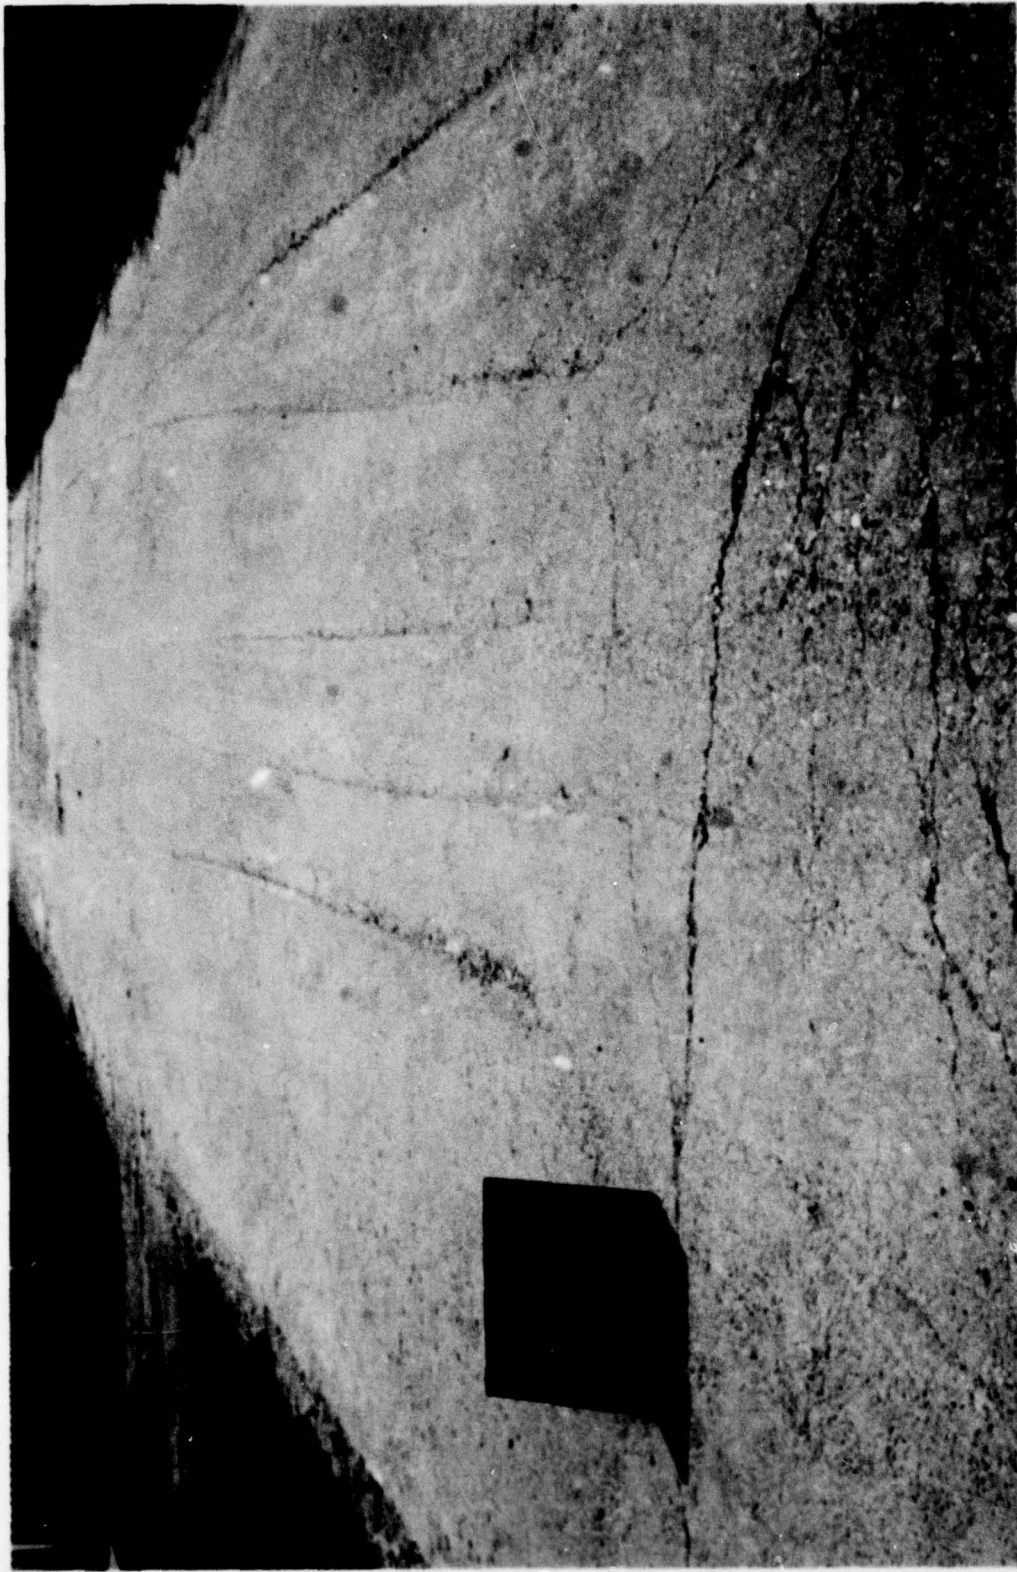
Photo 68. General view of item 1, lane 1, after 125,000 operations

of this item. The only distress detected between sta 0+10 and 0+60, the center portion of item 1, during traffic was slight flaking along the ridges formed by the roller during construction. After 125,000 operations, traffic was stopped because indications were that a very large amount of traffic would be required to produce any type of significant distress. This item was considered to be in excellent condition at this time. An overall view of item 1 after traffic is shown in Photo 68.

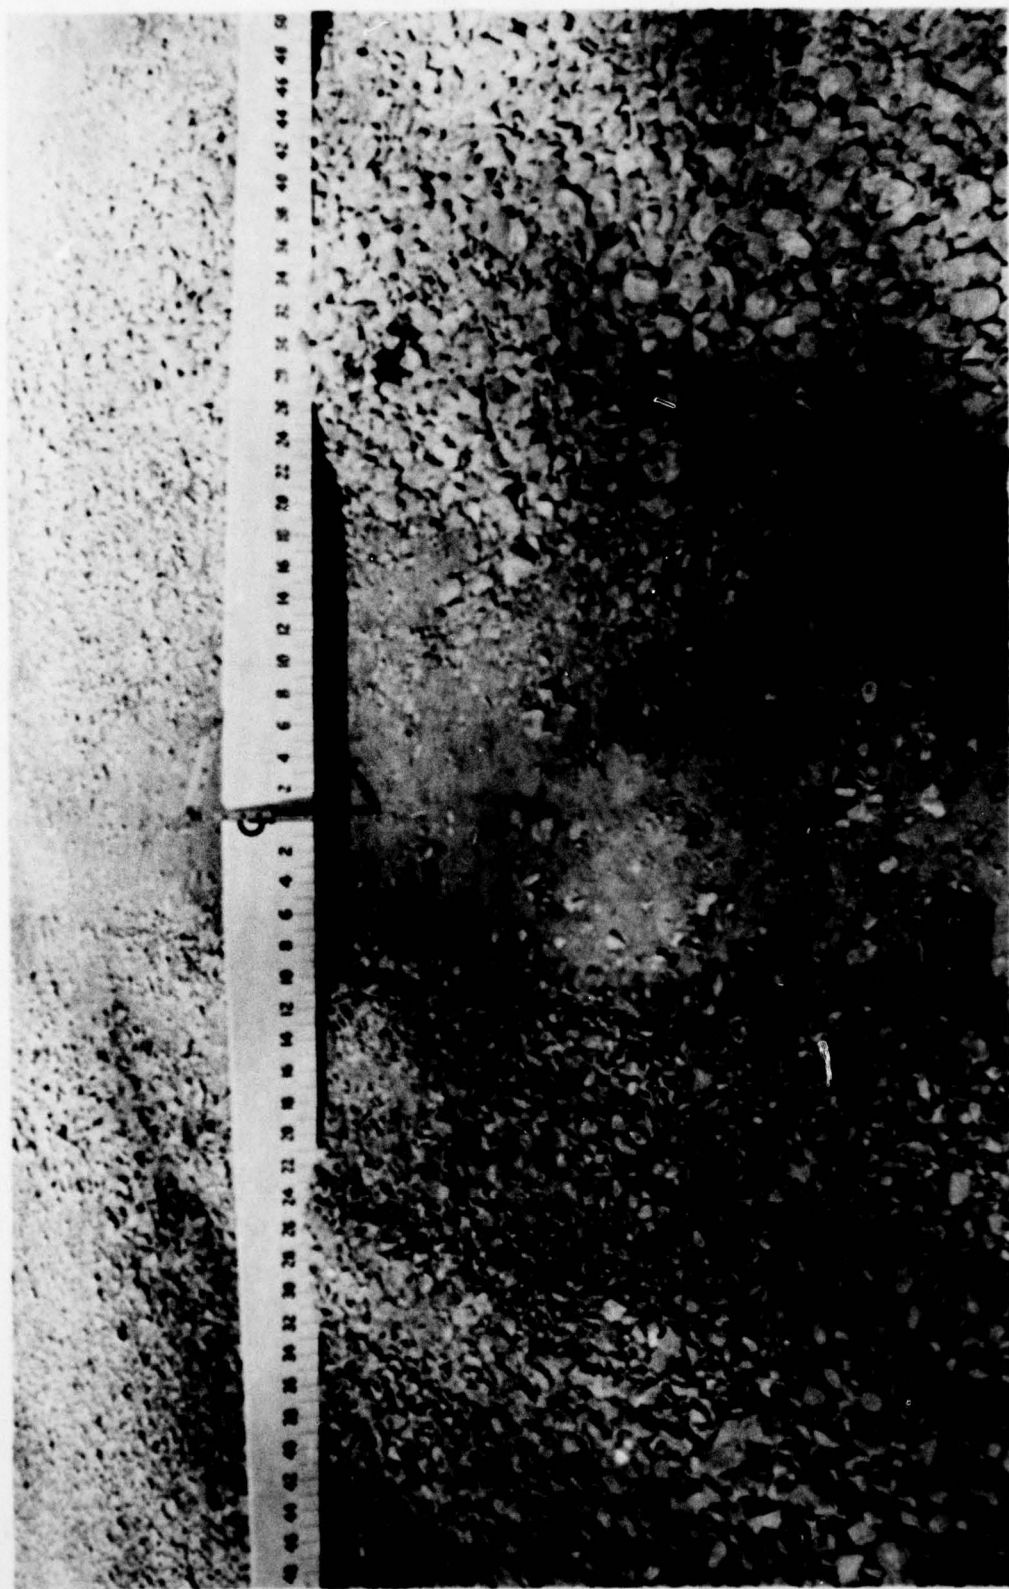
Photo 76. Close-up of 4-1/2-in.-deep rut in item 5 after 5390 operations

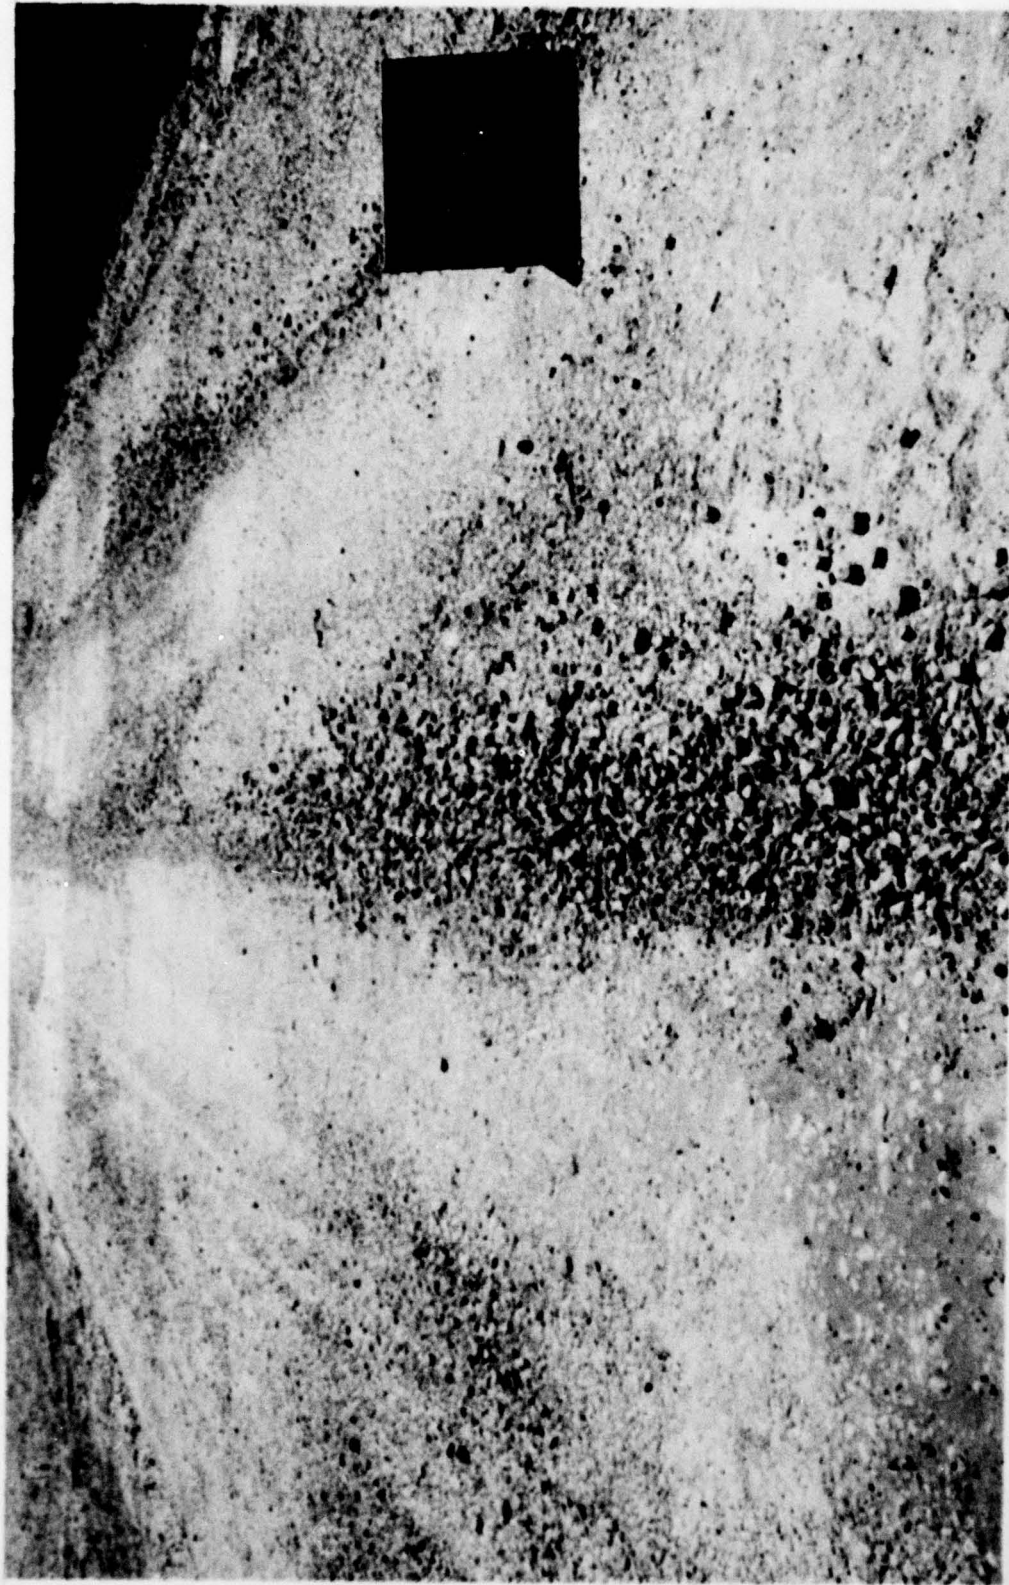
Photo 77. General view of item 5, lane 1, after 5390 operations (failure)

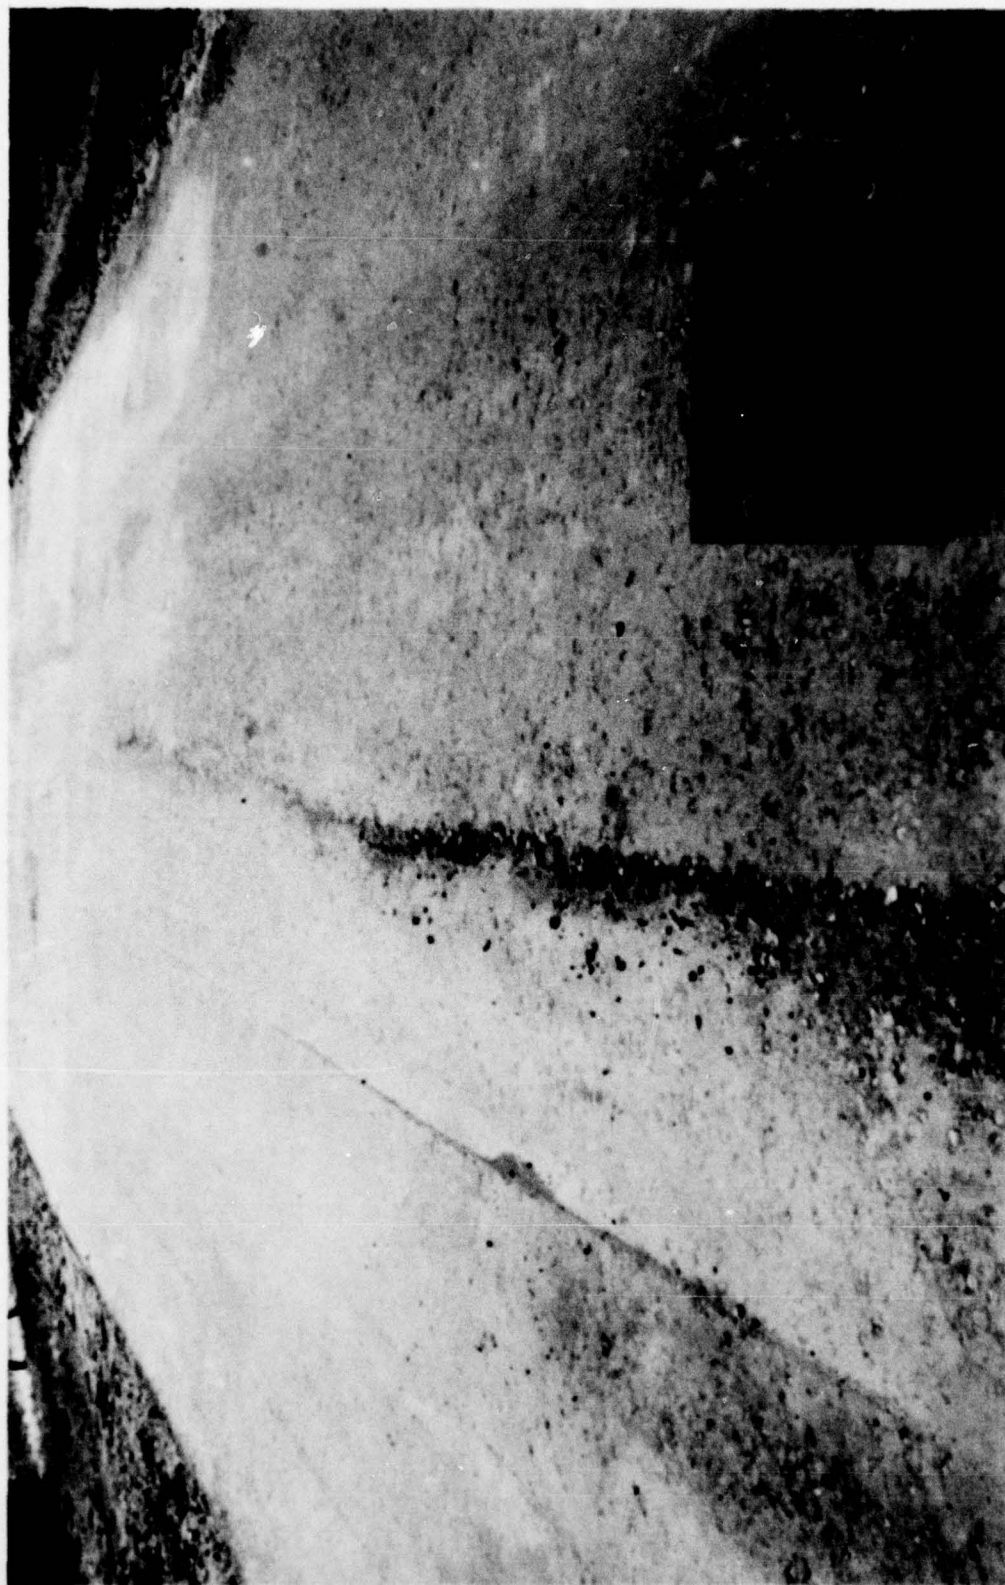
Photo 78. General view of item 6 (rigid pavement) prior to traffic

90. The condition of item 6 before the application of traffic is shown in Photo 78. Two transverse cracks extending across the width of the pavement were detected before traffic was commenced. Photo 79 is a closeup view of one of these cracks. The pavement in this item performed very well structurally during traffic testing. However, during wet weather traffic the surface became slippery. The first distress observed during traffic was several 2- to 3-ft-long hairline transverse cracks after 18,821 operations. No further cracks developed, and only slight spalling occurred during the remainder of traffic. Traffic was stopped after 125,000 operations because there were indications that a very large amount of traffic would be required to produce any significant distress. An overall view of item 6 at this time is shown in Photo 80. The performance of this item was rated good although the pavement performed excellently structurally during traffic. The good rating was assigned to this item because skid resistance decreased during wet weather.

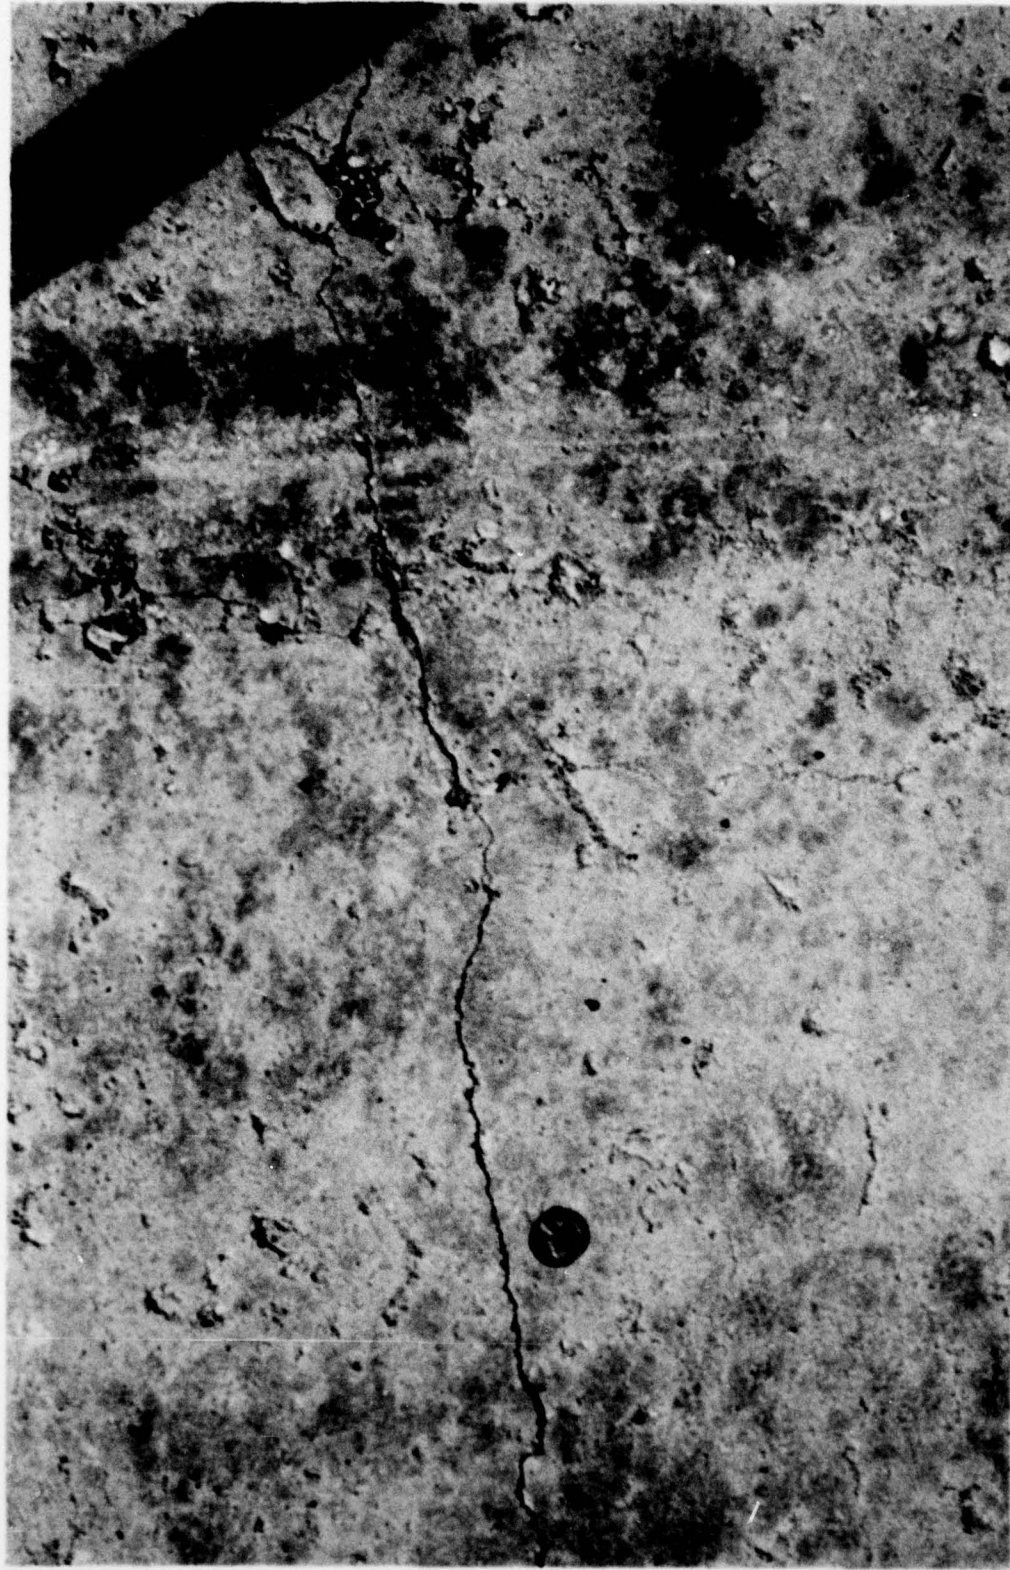
Photo 79. Contraction crack in item 6 prior to traffic
